**Flood Control Project Maintenance
Levee Inspections**

Fall 2018 Levee Maintenance Deficiency Summary Report

San Joaquin River Basin

Reclamation District No. 2089 Stark

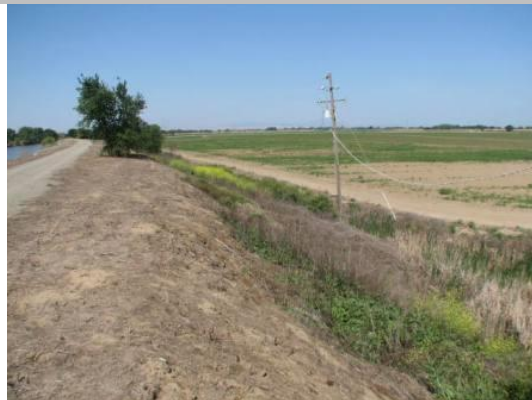
Photo 1 of 1 : FA_2018_RD2089_316_9_20180906_00009.jpg

LM Start	0.00	Rating **	M	Issue No.	9
LM End	0.38	Issue Type +	En	Location *	LS
Category	Earthen Levee			GPS Latitude/Longitude	
				Start	End
Item	Encroachments			37.811681 °	37.809755 °
				-121.384930 °	-121.391520 °
DWR ID	DWR_RD2089_01_s_2012_9				
Comment Code					
DT : Ditch					
Inspector Comment					
05/24/2011 Photo added of Ag ditch.

05/24/2011 Ditch flows parallel with the utility line shown in the photo.

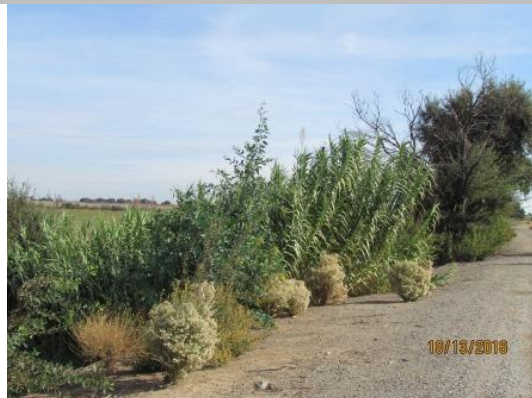
Photo 1 of 2 : FA_2018_RD2089_316_19_20180906_00015.jpg

View of the arundo back on the landside levee slope. Fall 2016

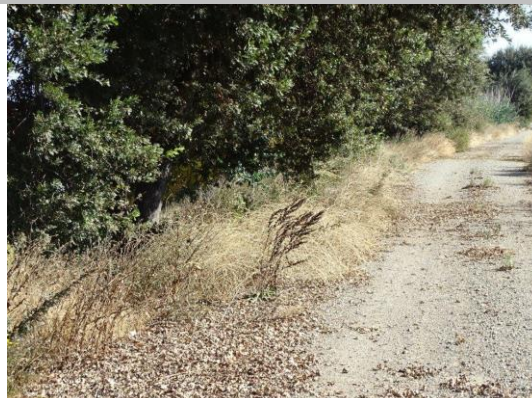
Photo 2 of 2 : FA_2018_RD2089_316_28_20181101_00058.jpg

LM Start	0.41	Rating **	U	Issue No.	28 (cont)	
LM End	0.46	Issue Type +	Ma	Location *	LS	
Category	Earthen Levee			GPS Latitude/Longitude		
				Start	End	
Item	Vegetation			37.809593 °	37.809507 °	
				-121.391963 °	-121.392907 °	
DWR ID	DWR_RD2089_01_s_2012_28					
Comment Code						
V2 : Remove the wild growth other than native grasses from the levee slopes.						
Inspector Comment						
Vegetation is too thick to allow access and visibility. Some thick patches of shrubs remain and continue to block visibility and access.

Looking at dense veg on landward slope. (Fall 2018)

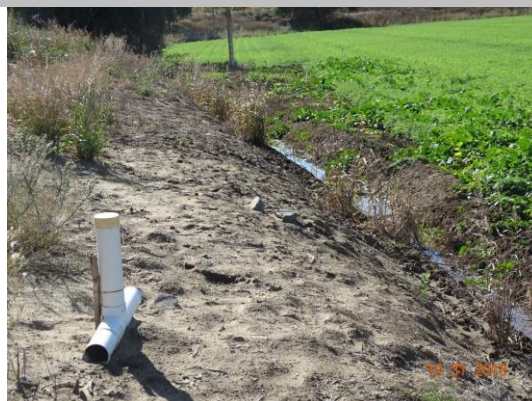
Photo 2 of 2 : FA_2018_RD2089_316_17_20181101_00059.jpg

LM Start	0.81	Rating **	U	Issue No.	17 (cont)	
LM End	0.94	Issue Type +	En	Location *	LS	
Category	Earthen Levee			GPS Latitude/Longitude		
				Start		End
Item	Encroachments			37.808319 °	37.806453 °	
				-121.397881 °	-121.397755 °	
DWR ID	DWR_RD2089_01_f_2014_17					
Comment Code						
AT : Agricultural tilling						
Inspector Comment						
Landside levee toe cut due to farming.

View of vertical cut along the landward toe. (Fall 2018)

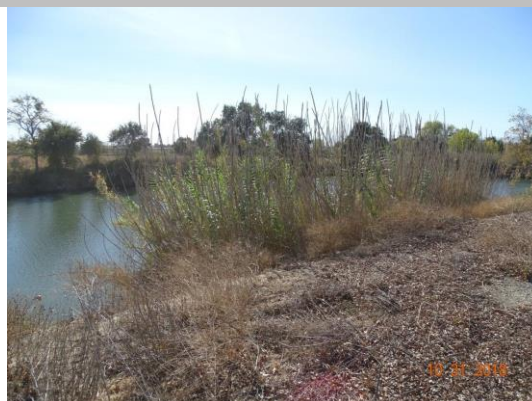
Photo 1 of 2 : FA_2018_RD2089_316_33_20181101_00061.jpg

LM Start	0.94	Rating **	U	Issue No.	33
LM End	0.94	Issue Type +	Ma	Location *	WS
Category	Earthen Levee			GPS Latitude/Longitude	
				Start	End
Item	Vegetation			37.806397 °	37.806397 °
				-121.397758 °	-121.397758 °
DWR ID	DWR_RD2089_01_s_2012_33				
Comment Code					
V2 : Remove the wild growth other than native grasses from the levee slopes.					
Inspector Comment					
Arundo on waterside impedes visibility and access to waterside slope.

Re-establishing of Arundo on waterward slope. (Fall 2018)

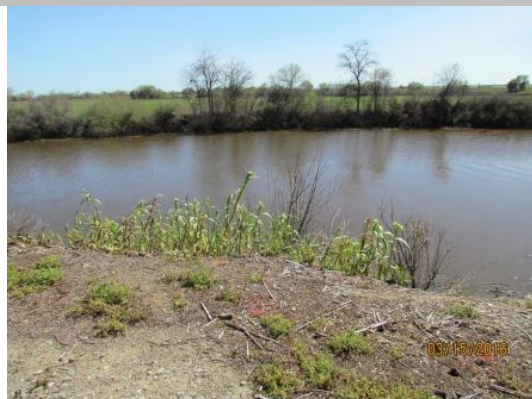
Photo 2 of 2 : FA_2018_RD2089_316_33_20180906_00030.jpg

Arundo was trimmed back and needs to be maintained to allow visibility and access.

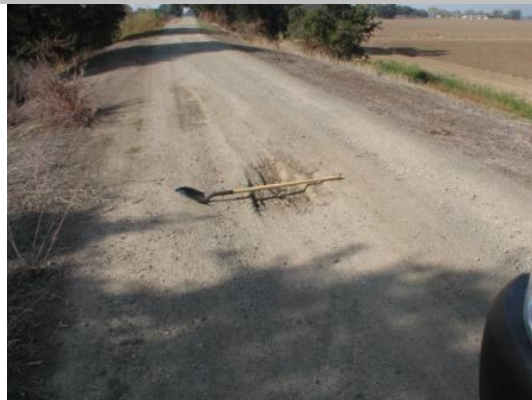
Photo 1 of 1 : FA_2018_RD2089_316_45_20180906_00034.jpg

LM Start	1.34	Rating **	M	Issue No.	45
LM End	1.34	Issue Type +	Ma	Location *	CR
Category	Earthen Levee			GPS Latitude/Longitude	
				Start	End
Item	Crown Surface / Depressions / Rutting			37.806128 °	37.806128 °
				-121.404890 °	-121.404890 °
DWR ID	DWR_RD2089_01_s _ 2012_45				
Comment Code					
C3 : Add appropriate gravel or road base. Grade and compact.					
Inspector Comment					
11/10/2011 Depression needs to be filled.

11/10/2011 Roadway depression.

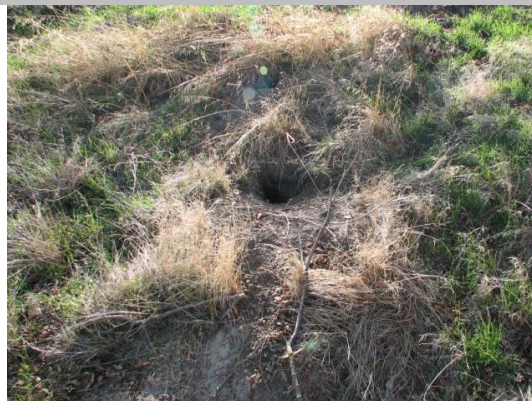
Photo 1 of 1 : FA_2018_RD2089_316_47_20180906_00035.jpg

LM Start	1.40	Rating **	M	Issue No.	47
LM End	1.40	Issue Type +	Ma	Location *	LS
Category	Earthen Levee			GPS Latitude/Longitude	
				Start	End
Item	Animal Control			37.806268 °	37.806268 °
				-121.405874 °	-121.405874 °
DWR ID	DWR_RD2089_01_s _ 2012_47				
Comment Code					
A3 : No rodents visible, but rodent burrows visible; need to backfill and compact or grout burrows.					
Inspector Comment					
11/10/2011 No rodents visible, but active burrows are present.

11/10/2011 Active rodent burrow on landside slope.

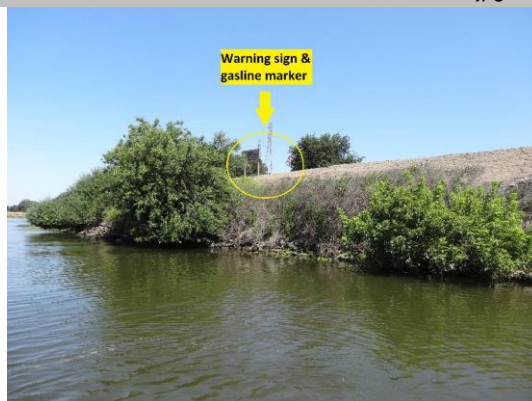
Photo 2 of 3 : UCIP_FA_2018_53182_74508.jpg

Gasline marker (for crossing with DS ID 25121) appr. 100 ft west of crossing.

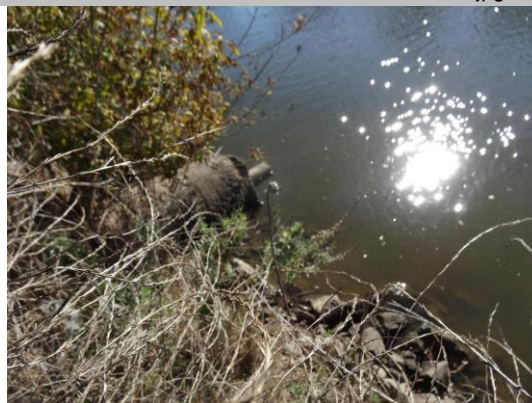
Photo 3 of 3 : UCIP_FA_2018_53182_76207.jpg

WS view of pipe

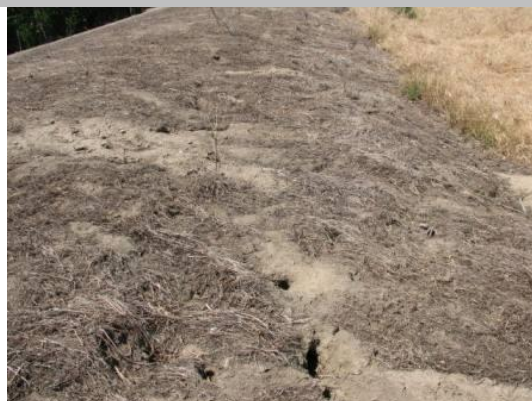
Photo 1 of 1 : FA_2018_RD2089_317_24_20180906_00023.jpg

LM Start	0.26	Rating **	M	Issue No.	24
LM End	0.26	Issue Type +	Ma	Location *	LS
Category	Earthen Levee			GPS Latitude/Longitude	
				Start	End
Item	Animal Control			37.809717 °	37.809717 °
				-121.410511 °	-121.410511 °
DWR ID	DWR_RD2089_02_s_2012_24				
Comment Code					
A1 : Exterminate rodents and backfill and compact or grout burrows.					
Inspector Comment					
Ground squirrel sighted and active burrowing in area.

05/24/2011 Active burrows, ground squirrel sighted in area.

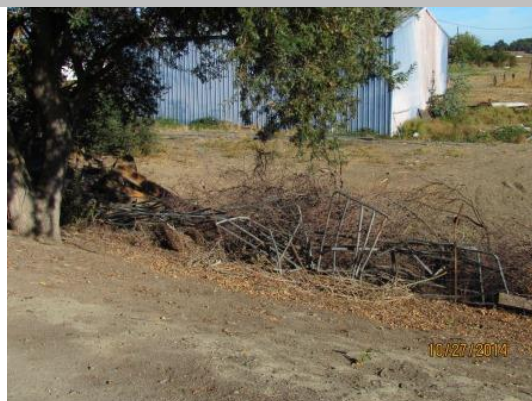
Photo 1 of 1 : FA_2018_RD2089_317_52_20180906_00050.jpg

LM Start	0.28	Rating **	U	Issue No.	52
LM End	0.30	Issue Type +	En	Location *	LS
Category	Earthen Levee			GPS Latitude/Longitude	
				Start	End
Item	Encroachments			37.809899 °	37.809997 °
				-121.410888 °	-121.411298 °
DWR ID	DWR_RD2089_02_f_2013_52				
Comment Code					
PR : Prunings					
Inspector Comment					
Remove prunings and other debris from the levee toe.

View of the tree branches on the landside levee toe obstructing access.

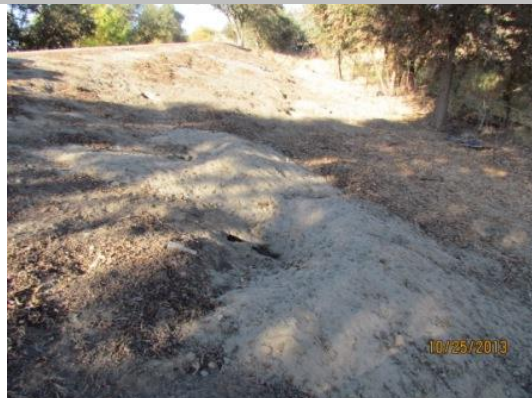
Photo 1 of 3 : FA_2018_RD2089_317_53_20180906_00051.jpg

View of the multiple rodent burrows on the landside levee slope.

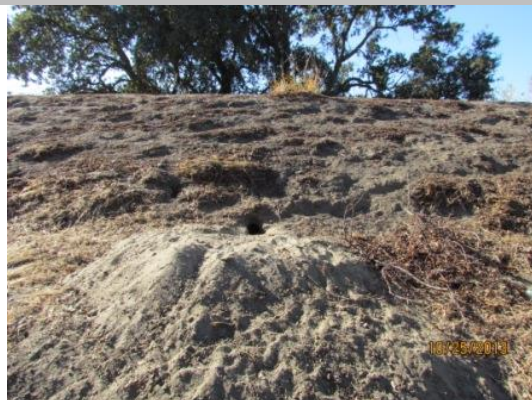
Photo 2 of 3 : FA_2018_RD2089_317_53_20180906_00052.jpg

View of the rodent burrow on the landside levee slope.

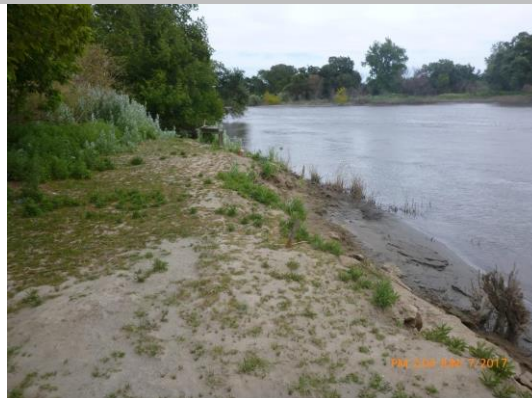
Photo 3 of 3 : LEVAL_FA_2018_109_1300.jpg

LM Start	0.32	Rating **	A/W	Issue No.	47 (cont)	
LM End	0.57	Issue Type +	Ma	Location *		
Category	Supplemental			GPS Latitude/Longitude		
				Start		End
Item	2017 Storm Damage			37.810020	°	37.811810
				-121.411550	°	-121.415390
DWR ID	DWR_RD2089_02_f_2017_47					
Comment Code						
Inspector Comment						
Levee Evaluation Comments						
Description:						
Site ID No:109						
Site Designation:335-103						
Repair Type: Erosion						
Rating:Area of Concern						
Field Date:6/7/2017						
Notes: vegetation too dense for evaluation

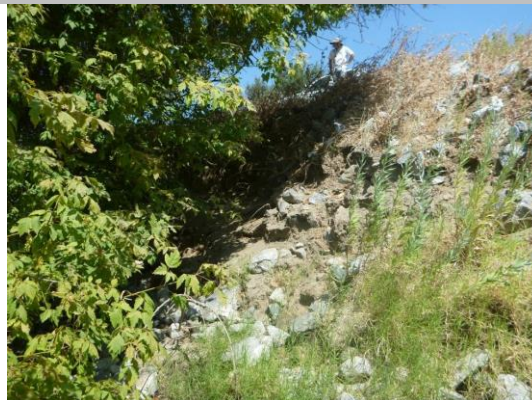
Photo 3 of 3 : LEVAL_FA_2018_508_4325.jpg

LM Start	0.39	Rating **	A/W	Issue No.	50 (cont)
LM End	0.41	Issue Type +	Ma	Location *	
Category	Supplemental			GPS Latitude/Longitude	
				Start	End
Item	2017 Storm Damage			37.810150 °	37.810270 °
				-121.412930 °	-121.413240 °
DWR ID	DWR_RD2089_02_f _ 2017_50				
Comment Code					
Inspector Comment					
Levee Evaluation Comments					
Description:Slope protection repairs are needed along the waterside slope due to erosion and riprap displacement from high water. Based upon levee inspections, it was determined the waterside levee slope is eroding, deteriorating, and degrading. The eroded levee sections need to be restored back to design standards to prevent further deterioration and damage.					
Site ID No:508					
Site Designation:LMA-414					
Repair Type: Erosion					
Rating:Serious					
Field Date:8/16/2017					
Notes: Large erosion around tree with a 12' vertical cut.

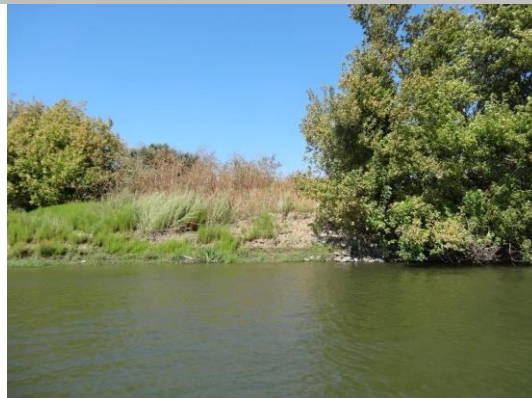
Photo 1 of 3 : FA_2018_RD2089_317_1_20180906_00001.jpg

Front view of the site.

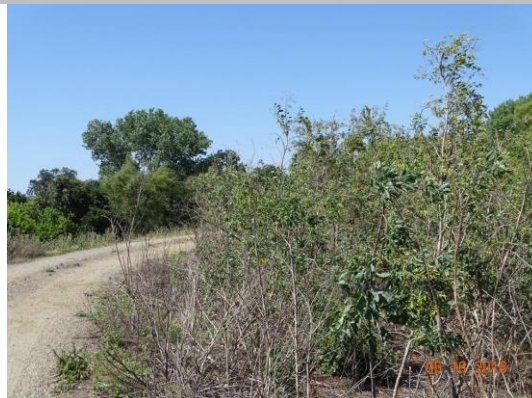
Photo 1 of 1 : FA_2018_RD2089_317_62_20180906_00060.jpg

LM Start	0.43	Rating **	M	Issue No.	62
LM End	0.93	Issue Type +	Ma	Location *	LS
Category	Earthen Levee			GPS Latitude/Longitude	
				Start	End
Item	Vegetation			37.810453 °	37.814923 °
				-121.413533 °	-121.416290 °
DWR ID	DWR_RD2089_02_s _ 2018_62				
Comment Code					
V2 : Remove the wild growth other than native grasses from the levee slopes.					
Inspector Comment

View of wild growth on the partially visible landside slope. Spring 2018.

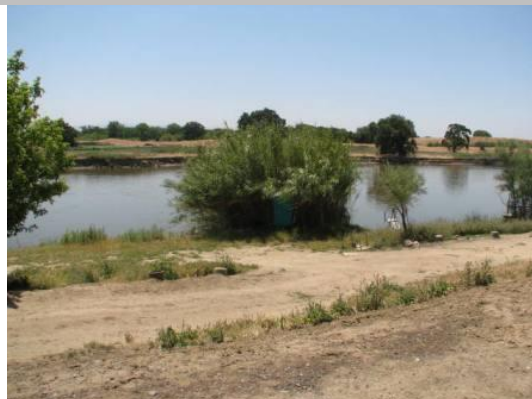
Photo 1 of 3 : FA_2018_RD2089_317_27_20180906_00025.jpg

LM Start	0.44	Rating **	M	Issue No.	27
LM End	0.44	Issue Type +	En	Location *	WS
Category	Earthen Levee			GPS Latitude/Longitude	
				Start	End
Item	Encroachments			37.810490 °	37.810490 °
				-121.413638 °	-121.413638 °
DWR ID	DWR_RD2089_02_s _ 2012_27				
Comment Code					
BU : Building					
Inspector Comment					
Portable toilet on bank, at water's edge. And other items.

05/24/2011 Portable toilet is in the shadows in the center of the photo at the water's edge.

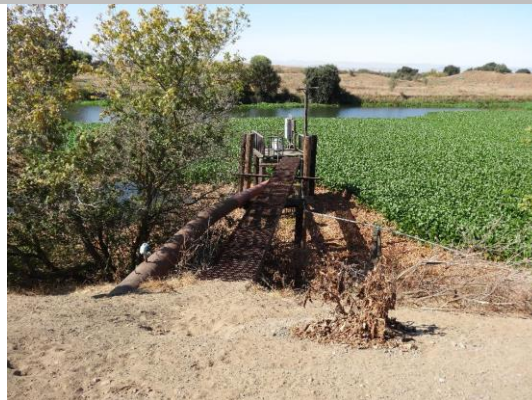
Photo 1 of 3 : UCIP_FA_2018_21676_36861.jpg

WS view: pipe and pump on piling structure in water channel.

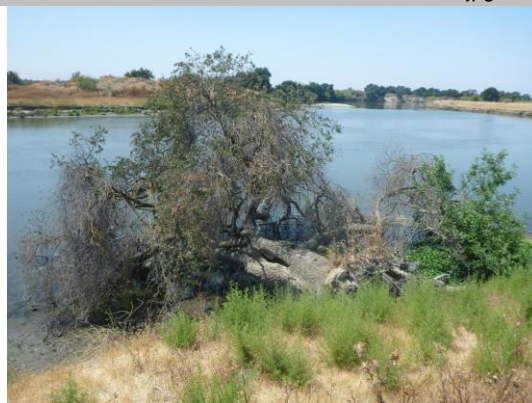
LM Start	0.60	Rating **	A/W	Issue No.	56
LM End	0.61	Issue Type +	Ma	Location *	
Category	Supplemental			GPS Latitude/Longitude	
				Start	End
Item	2017 Storm Damage			37.812000 °	37.812100 °
				-121.415700 °	-121.415900 °
DWR ID	DWR_RD2089_02_s_2018_56				
Comment Code					
Inspector Comment					
Levee Evaluation Comments					
Description:Slope protection repairs are needed along the waterside slope due to erosion and riprap displacement from high water. Based upon levee inspections, it was determined the waterside levee slope is eroding, deteriorating, and degrading. The eroded levee sections need to be restored back to design standards to prevent further deterioration and damage.					
Site ID No:507					
Site Designation:LMA-413					
Repair Type: Erosion					
Rating:Serious					
Field Date:8/16/2017					
Notes: Vertical cut on outside bend of river

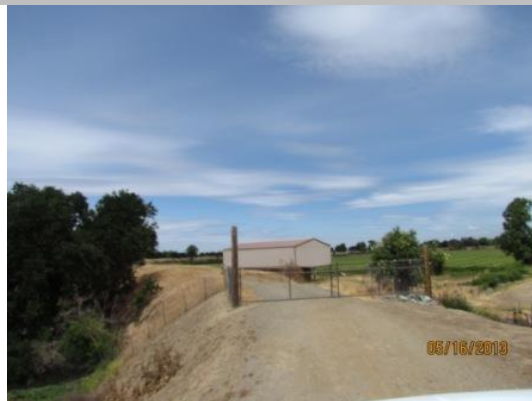
Photo 1 of 1 : FA_2018_RD2089_317_9_20180906_00009.jpg

LM Start	0.84	Rating **	M	Issue No.	9
LM End	0.84	Issue Type +	En	Location *	CR
Category	Earthen Levee		GPS Latitude/Longitude		
			Start	End	
Item	Encroachments		37.814881 °	37.814881 °	
			-121.414676 °	-121.414676 °	
DWR ID	DWR_RD2089_02_s _ 2012_9				
Comment Code					
FE : Fence					
Inspector Comment					
Gate across levee crown.

View of the fence gate across levee crown.

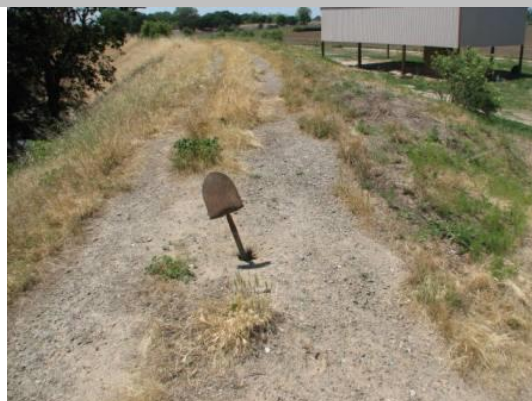
Photo 2 of 3 : FA_2018_RD2089_317_40_20180906_00034.jpg

LM Start	0.85	Rating **	U	Issue No.	40 (cont)	
LM End	0.90	Issue Type +	Ma	Location *	LS	
Category	Earthen Levee			GPS Latitude/Longitude		
				Start		End
Item	Animal Control			37.814997 °		37.814970 °
				-121.414774 °		-121.415767 °
DWR ID	DWR_RD2089_02_s_2012_40					
Comment Code						
A1 : Exterminate rodents and backfill and compact or grout burrows.						
Inspector Comment						
Numerous burrows on landside slope adjacent to hay storage area. Deep burrows in crown and landside ramp.

05/24/2011 Deep vertical burrow in levee crown.

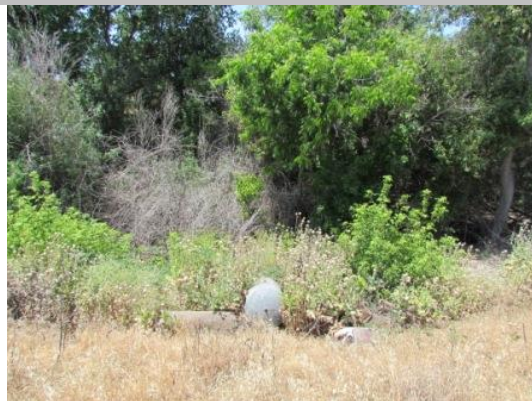
Photo 1 of 1 : FA_2018_RD2089_317_17_20180906_00018.jpg

LM Start	1.08	Rating **	M	Issue No.	17
LM End	1.08	Issue Type +	Ma	Location *	WS
Category	Earthen Levee			GPS Latitude/Longitude	
				Start	End
Item	Encroachments			37.816025 °	37.816025 °
				-121.418544 °	-121.418544 °
DWR ID	DWR_RD2089_02_s_2012_17				
Comment Code					
DE : Debris					
Inspector Comment					
Water tanks disposed of on levee are obstructive.

View of water tanks disposed on waterside slope.

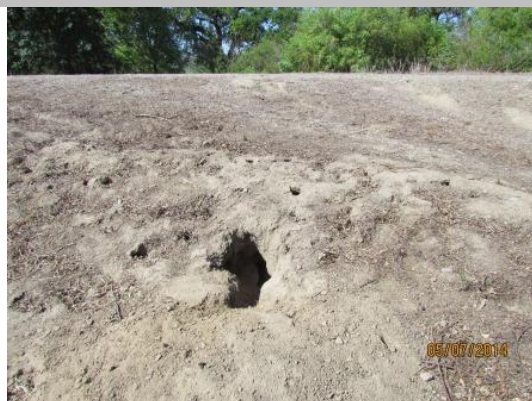
Photo 1 of 1 : FA_2018_RD2089_317_6_20180906_00006.jpg

LM Start	1.18	Rating **	M	Issue No.	6
LM End	1.18	Issue Type +	Ma	Location *	LS
Category	Earthen Levee			GPS Latitude/Longitude	
				Start	End
Item	Animal Control			37.817271 °	37.817271 °
				-121.419380 °	-121.419380 °
DWR ID	DWR_RD2089_02_s_2014_6				
Comment Code					
A1 : Exterminate rodents and backfill and compact or grout burrows.					
Inspector Comment

View of the large rodent hole on the landside levee slope.

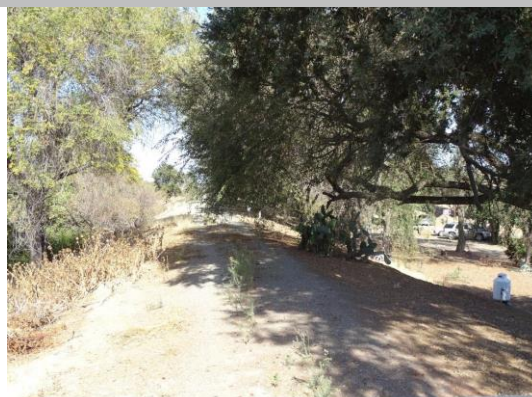
Photo 1 of 1 : FA_2018_RD2089_317_33_20181101_00068.jpg

LM Start	1.26	Rating **	U	Issue No.	33
LM End	1.26	Issue Type +	Ma	Location *	CR
Category	Earthen Levee			GPS Latitude/Longitude	
				Start	End
Item	Trim / Thin Trees			37.818408 °	37.818408 °
				-121.419738 °	-121.419738 °
DWR ID	DWR_RD2089_02_f_2018_33				
Comment Code					
T4 : Trim trees over roadway to at least 12 feet above ground level.					
Inspector Comment					
Tree on landward slope overhanging crown of levee.

Looking west at trees overhanging crown of levee. (Fall 2018)

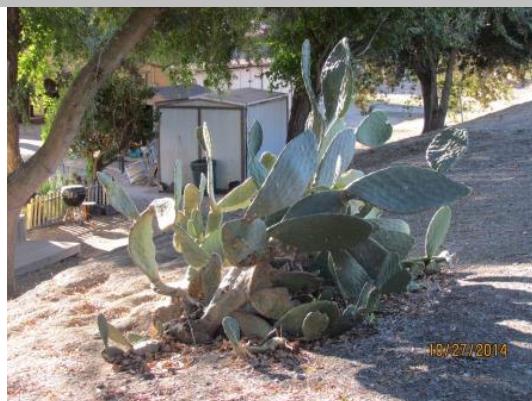
Photo 1 of 1 : FA_2018_RD2089_317_57_20180906_00059.jpg

LM Start	1.27	Rating **	M	Issue No.	57
LM End	1.27	Issue Type +	En	Location *	CR
Category	Earthen Levee			GPS Latitude/Longitude	
				Start	End
Item	Vegetation			37.818499 °	37.818499 °
				-121.419754 °	-121.419754 °
DWR ID	DWR_RD2089_02_f_2013_57				
Comment Code					
V6 : Landscaping					
Inspector Comment					
Remove cactus from levee crown.

View of the cactus on the landside levee shoulder.
